REPORT OF AIRCRAFT ACCIDENT

ACCIDENT NO. *416*

(1) Place: Castelluccio Air Field

AIRCRAFT: (2) Type and model: B-24H *15* (3) A. F. No. A2-94908 (4) Station: Castelluccio Air Field
Organization: (5) 15th AF (6) 451st Bomb Gp (7) 725th Bomb Sq.
(Command and Air Force) (Group) (Squadron)PERSONNEL *1167*

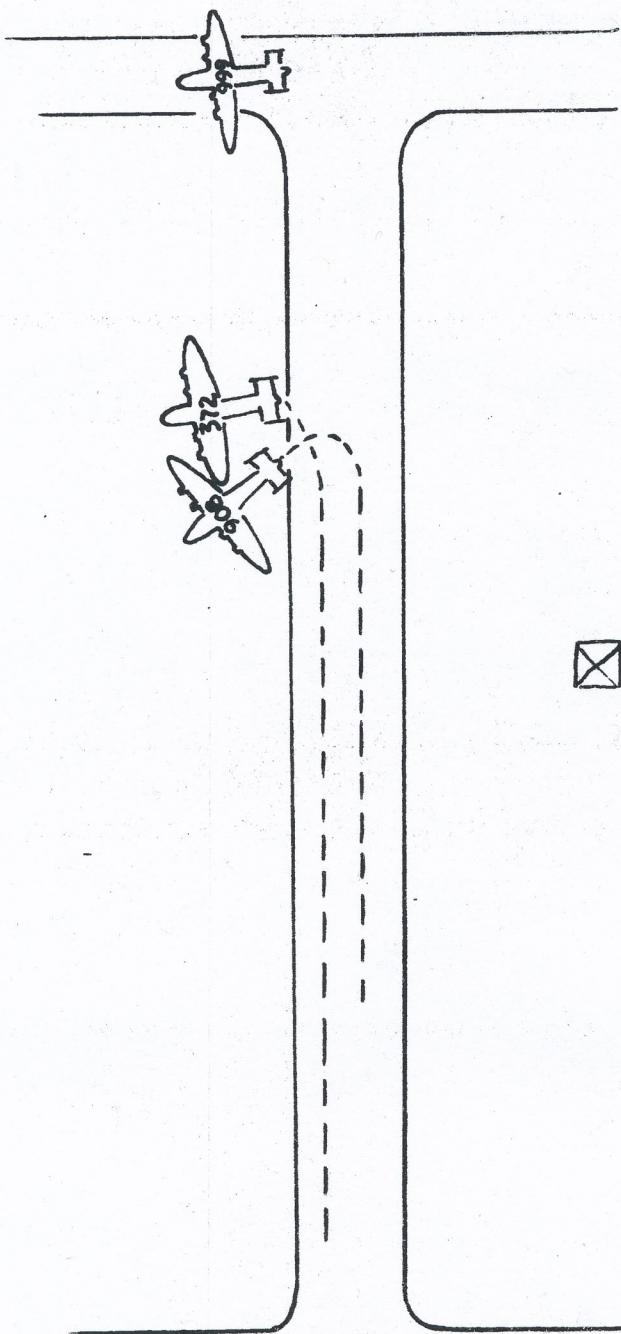
Aircraft was returning from combat mission with bombs aboard. Accident occurred during landing at base during period of severe weather conditions, causing strong, gusty, crosswinds and slippery runway. All ships had been instructed by tower to land short because of slippery runway; however, this ship landed in the second third of runway, and attempts to get directional control were unsuccessful, resulting in collision with damaged aircraft parked at the edge of runway.

Ship #308 was making his approach simultaneously and when he called he was informed of the slippery condition of the runway, that his approach was too long and, on the base leg, that he had better go around. It is believed that this ship was not in contact with the tower. He touched down on the runway approximately in front of the tower and applied brakes immediately. This seem to cause the ship to skid sideways along the runway. He left the runway and collided with ship #372 as his ship came to rest.

All pilots have been instructed in necessity of landing short on slippery runway with bomb load. Tower officers have been instructed that all damaged aircraft endangering other landing aircraft will be removed to a safe distance before landings are again permitted. Go-arounds are mandatory if landing cannot be effected in first third of runway.
